# Chapter 7

## Retrieval Study

## 7.1 INTRODUCTION

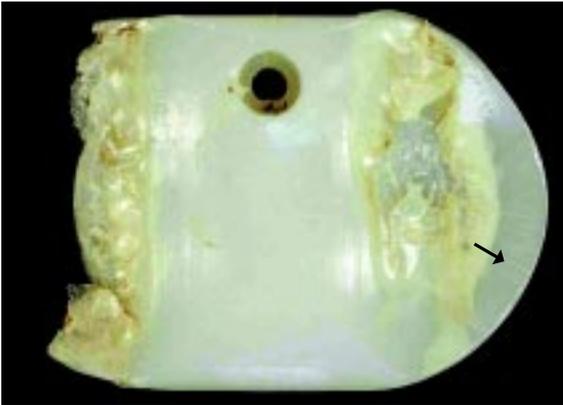
*Figure 7.4. Surface deformation: areas with permanent deformation occurring on or around the articulating surfaces, presumably caused by cold flow and /or creep.*

- Burnishing: areas that have become highly polished<sup>218;219</sup> (see Figure 7.1).
- Scratching: indented lines generally found in an anteroposterior direction and in the areas of wear. Scratches were differentiated from marks made by instruments during removal of the component. Such marks usually do not coincide with the wear areas or they do not occur in the correct direction (see Figure 7.2).
- Pitting (or crater formation): depressions in the articulating surface, measuring 2-3 mm across and 1-2 mm deep<sup>220</sup> (see Figure 7.3).
- Surface deformation: areas with permanent deformation occurring on or around the articulating surface, presumably caused by cold flow and/or creep (see Figure 7.4).

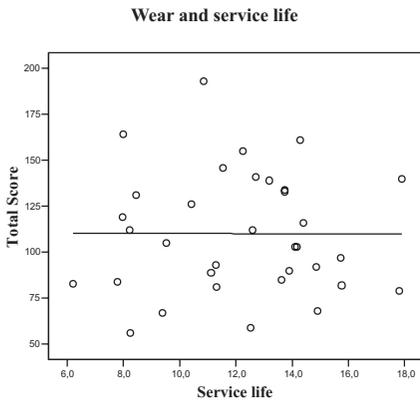
There was no significant relation between service life and the amount of damage (linear regression analysis,  $B=-0.042$ ,  $p=0.983$ ) (see Figure 7.18).

**Figure 7.18.** Score of damage and service life. Inserts with a longer service life did not have a higher total score of damage (linear regression analysis,  $B=-0.042$ ,  $p=0.983$ ).
